# Taylor Pearce Limited, Fishers Court, Besson Street, London SE14 5AS

All Saints' Church Hertford Alabaster Reredos Completion Report February 2019

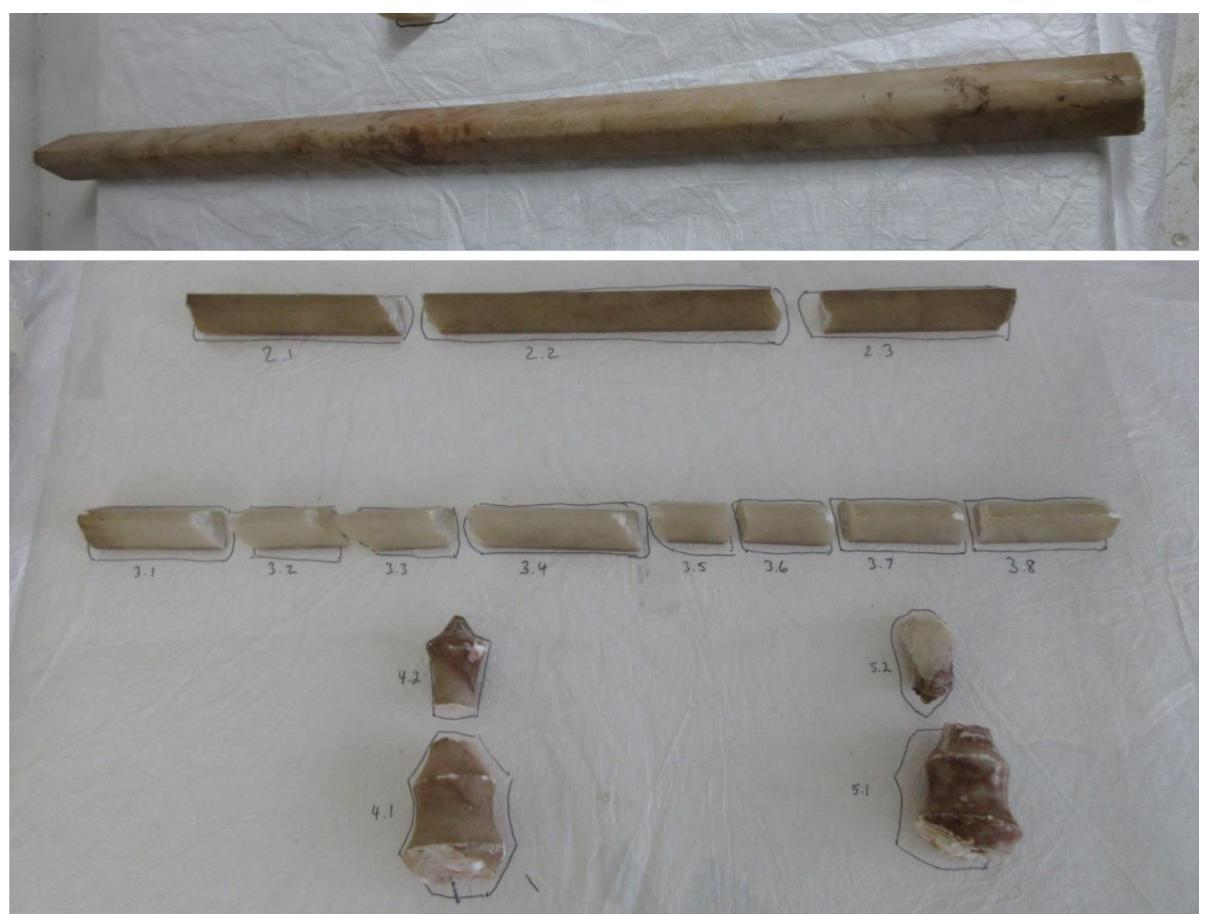
Several small elements (finials from both north and south towers and mullions from the middle and lower sections of tracery on both sides) had become detached and in some cases broken (Image 2). In addition, both mullions and jambs on the tracery on the lower sections (particularly on the north tower) were loose and in danger of detaching. Taylor Pearce Limited was, therefore, commissioned in June 2018 to assess the causes of the damage and devise a plan to treat the reredos as a whole. The current document should be read together with the report produced at that time (*Condition report and conservation proposals June 2018*) for a full discussion of the condition before treatment.

Image 2: Intact but detached mullion (top) and fragments of two mullions (middle) and two finials (bottom).

Alabaster reredos All Saints' Hertford Two mullions from the lower section of tracery on the north tower were broken; one into eight sections and the other into three (Image 2). The break surfaces were coated with a barrier layer of 20% Paraloid B72 in acetone and allowed to dry. The sections were then readhered using polyester resin (Akemi); losses were filled using gypsum plaster and retouched with acrylic paints to colour-match adjacent surfaces.

Two detached finials were stored with the other fragments at the church (Image 2); both had been previously repaired; the top was attached using a copper alloy pin set in plaster in one. All old adhesive was removed and the pin was replaced with a 3mm diameter acrylic dowel. Break surfaces were coated with a barrier layer of 20% Paraloid B72 in acetone and the fragments were adhered using polyester resin (Steinkitt). Lost material adjacent to break surfaces were filled using gypsum plaster and retouched using acrylic paint (Images 22 and 23). Two further finials were removed from the octagonal tracery at the top of each tower and cleaned; a copper alloy pin was removed from the finial from the north tower.

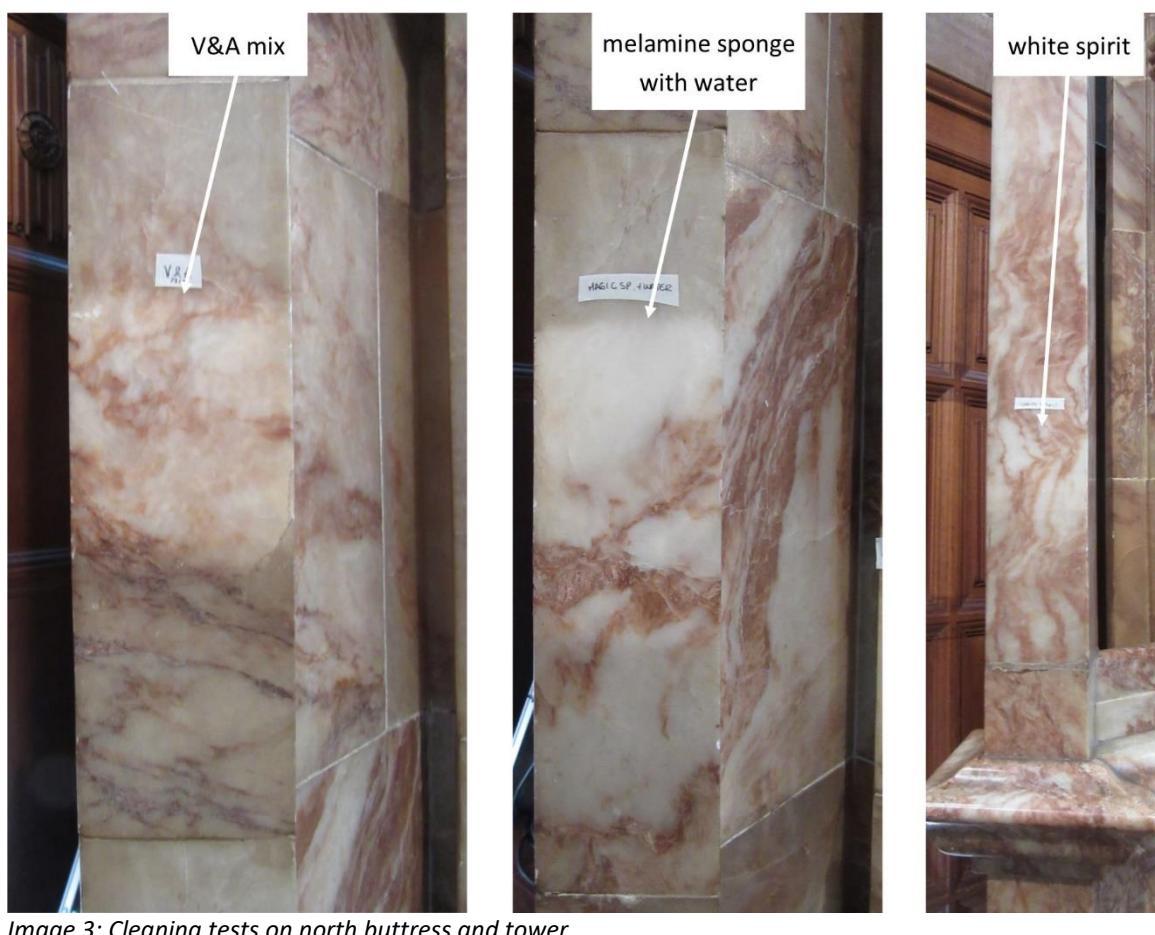
Image 3: Cleaning tests on north buttress and tower.

Tests were carried out to establish a method for the removal of residual staining and more ingrained dirt. Wishab sponges and smoke sponges were trialled as dry cleaning methods. White spirit, V&A mix (1:1 emulsion of white spirit and water with a drop of non-ionic detergent) and acetone were applied using cotton wool swabs; melamine sponges dampened with water and a 1:1 mix of water and IMS were also trialled. The melamine sponge dampened with water was found to be the most successful method and also avoided the need to use solvents in a busy church (Image 3). The whole surface including the reverse side was cleaned using this method (Image 5).

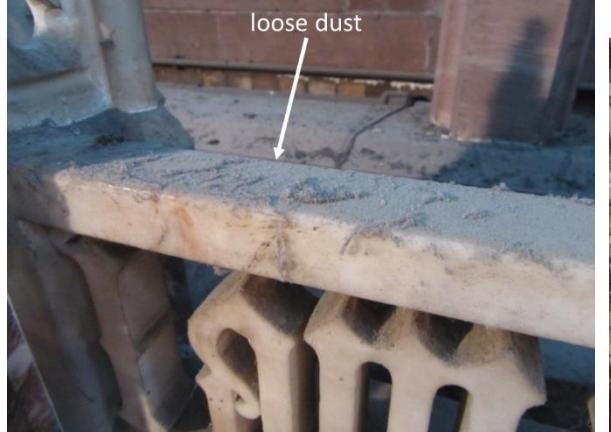
Image 4: Loose dust and dirt before cleaning on south side of inscription.

Loose dust and dirt were removed from the whole surface using soft bristle brushes and vacuum cleaners (Image 4).

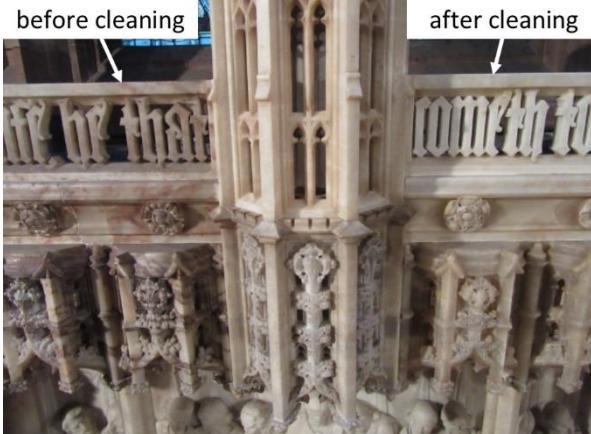
Image 5: Central tower and inscription before (left) and after (right) cleaning.

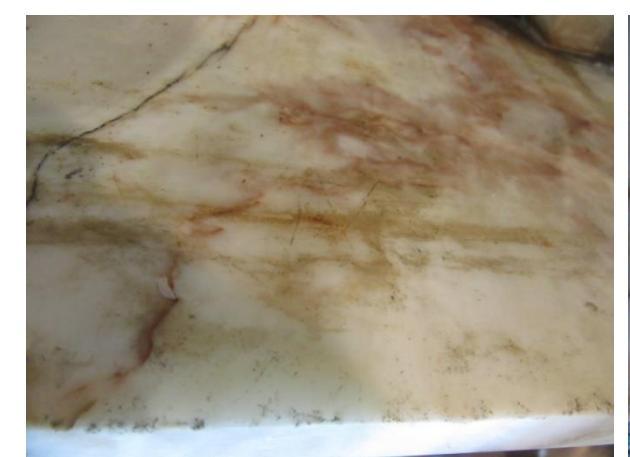
*Image 6: Upper surface of shelf with adhesive residues from tape before poulticing.*

On the upper surface of the shelf there were residues from tape adhesive (Image 6). These were poulticed using cotton wool soaked in acetone and covered in cling-film to soften the adhesive, which could then be removed with a melamine sponge (Image 7).

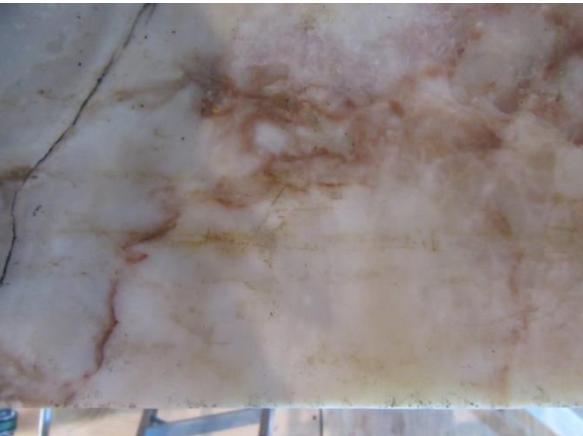
Image 7: Upper surface of shelf after poulticing with acetone to reduce residues.

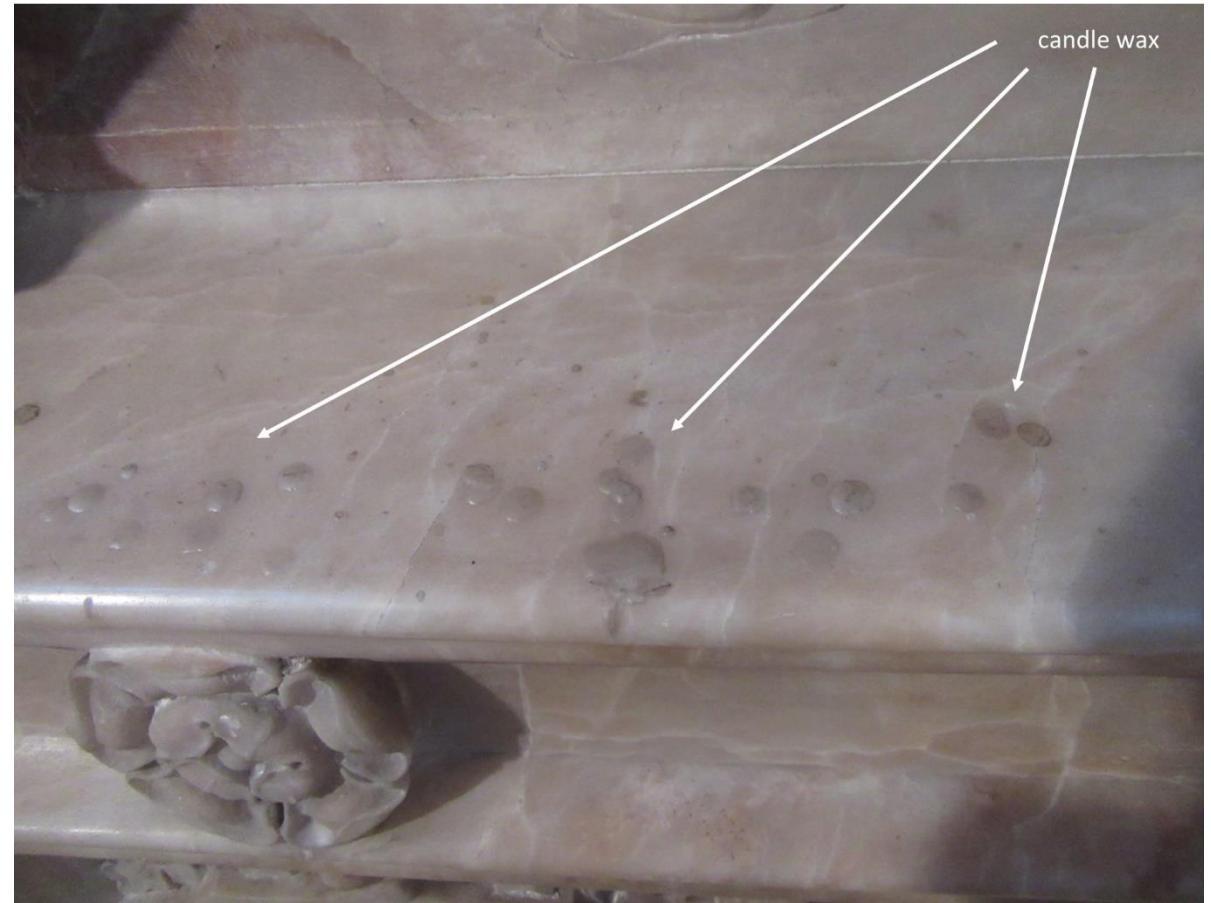
Image 8: Candle wax on surface below relief panel.

The top surface of the shelf, the bases of the niches housing the figures on the north and south sides and the lower section of the central relief panel were covered in splashes of candle wax (Image 8). These were reduced using scalpels and wooden tools before removing any remaining wax with a dampened melamine sponge.

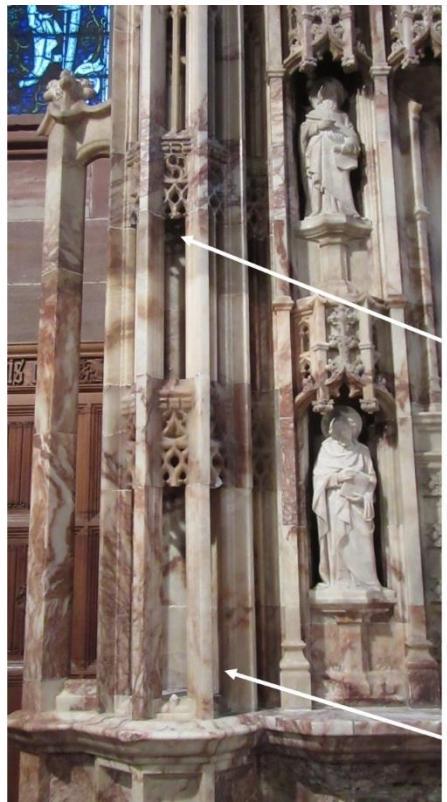
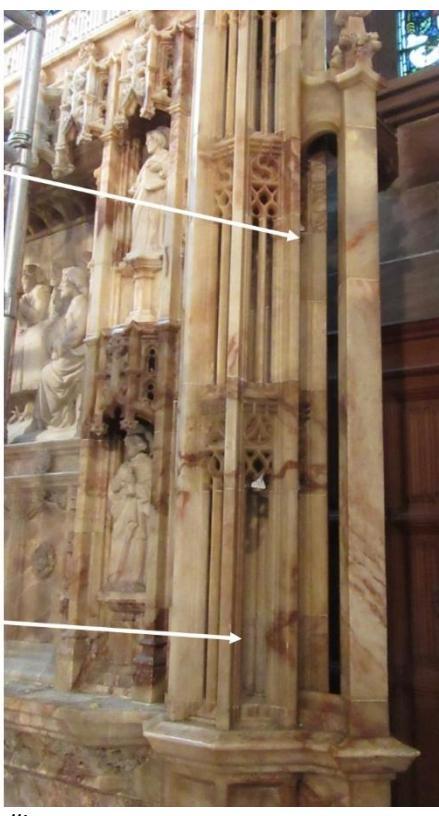
All mullions that were loose were removed: two from the lower section of the north tower, three from the lower section of the south tower and one from the middle section of the south tower (Image 9). Two of the mullions from the lower section of the south side were broken. One had been repaired previously and pinned with a short copper alloy dowel; this was secure on one side and was left in place to prevent further damage (Image 10). The broken mullions were readhered using polyester resin (Steinkitt).

1 mullion removed from middle section on south tower (south side)

1 mullion removed from middle section on north tower

3 mullions removed from lower section on south tower

4 mullions removed from lower section on north tower

Image 9: North (left) and south (right) towers following removal of mullions.

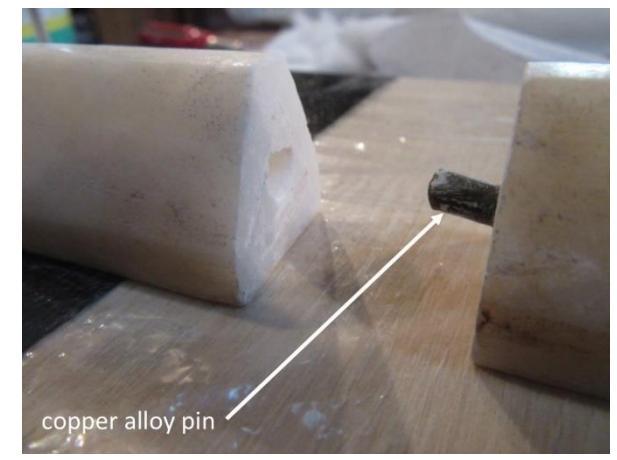
Image 10: Mullion from lower section of south tower with old repair.

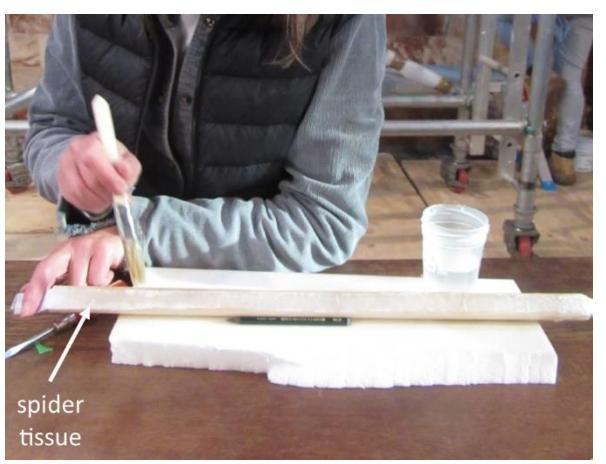
Image 11: Adhering 'Spider Tissue' to reverse side of mullion from north tower.

The backs of the mullions were then reinforced using three layers of 'Spider Tissue' adhered with 20% Paraloid B72 in acetone. The strips of tissue were cut so they would overhang the ends of each mullion by 15mm (Image 11). The same reinforcement was applied to the backs of all the mullions that were removed including the two mullions from the lower section of the south tower which had also been repaired.

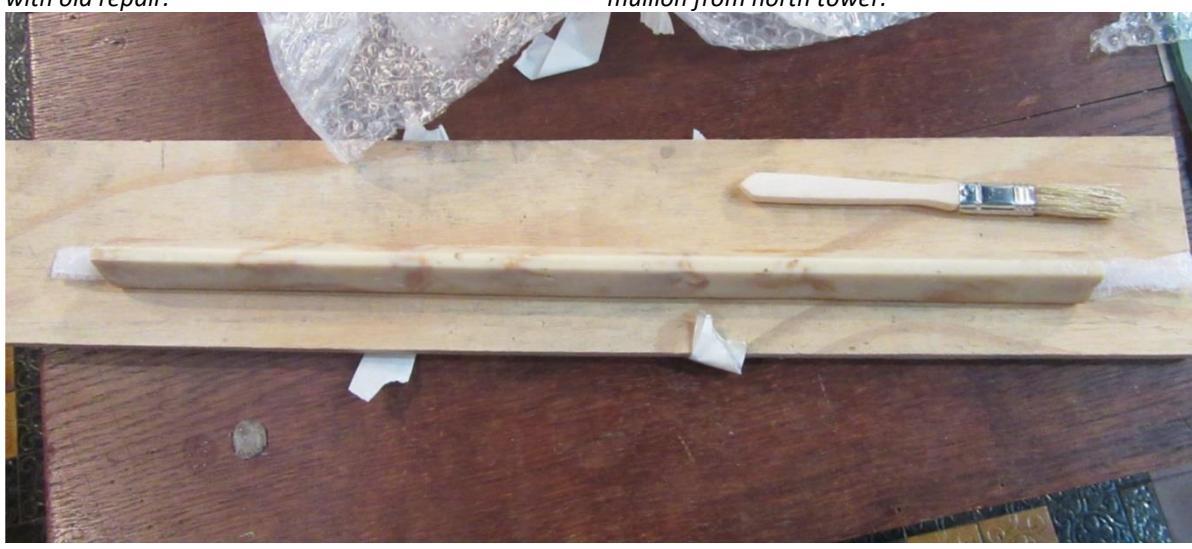
Image 12: Replacement mullion for lower section of north tower made from polyester resin.

A replacement for the missing mullion for the centre of the middle section of tracery on the north side was made by taking a mould from one of the detached mullions in the lower section of tracery on the north side. A new mullion was cast using polyester resin (Akemi and Steinkitt) mixed with onyx powder and pigments to colour match the original alabaster. The resin was reinforced using glass fibre in a channel down the centre of the mullion. Using 20% Paraloid B72 in acetone, a short length of 'Spider Tissue' was attached to the back of the replacement mullion overhanging at each end by approximately 15mm (Image 12).

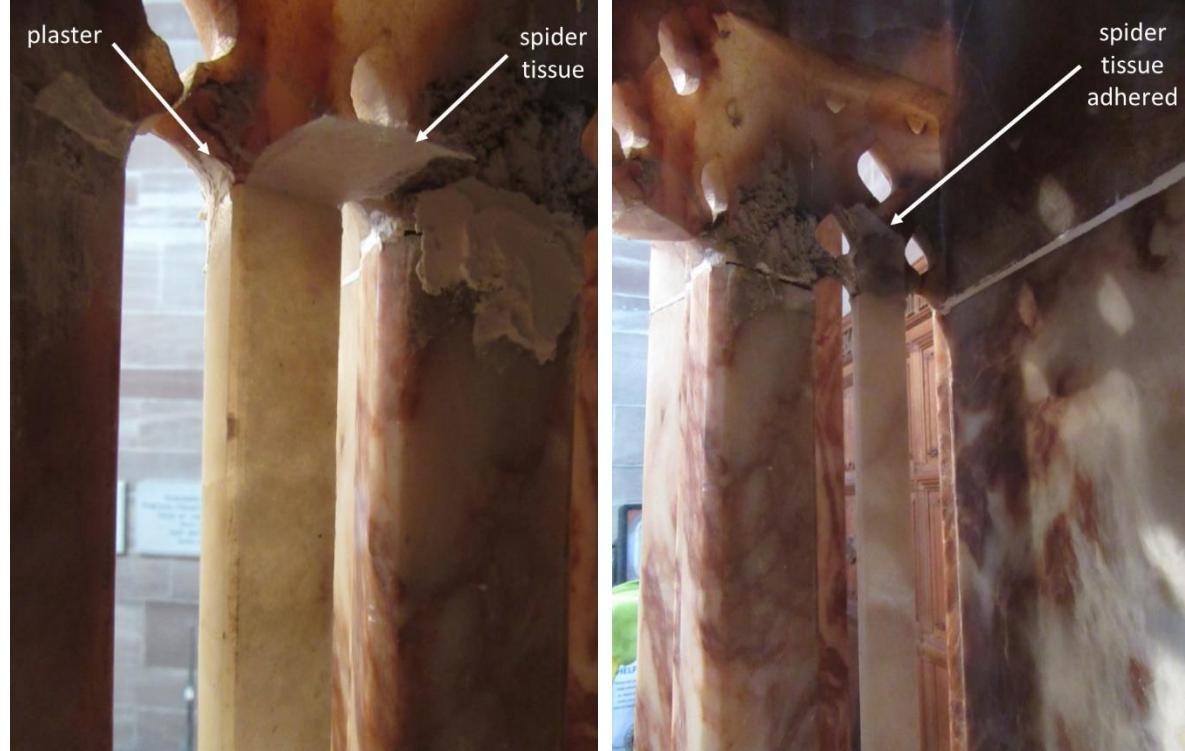
Image 13: Mullion set in casting plaster.

Image 14: Mullion after spider tissue adhered.

The mullions were attached by resetting them top and bottom in gypsum plaster; where necessary, a small plastic spacer was placed on the lower surface to ensure that upper and lower joints were even. Once the plaster had cured, the overhanging tabs of spider tissue were adhered to the adjacent surface using 20% Paraloid B72 in acetone (Images 13 and 14); the joints were then further reinforced using gypsum plaster. The new plaster joints were retouched to match existing plaster joints using acrylic paint (Image 15).

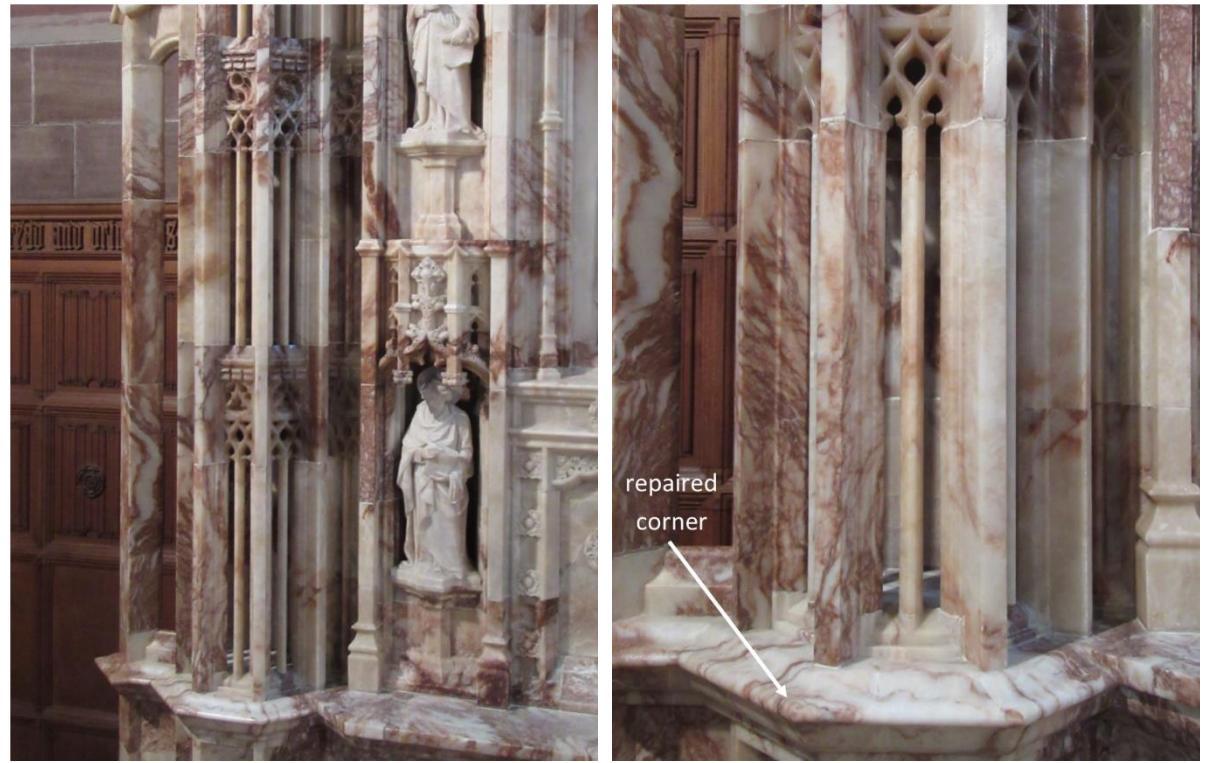
Image 15: Reinstated mullions in lower and middle sections of north tower.

Image 16: All four jambs in lower section of tracery on north tower following stabilisation with gypsum plaster and repaired corner of shelf.

Three of the jambs at the bottom of the north tower and one of the jambs at the bottom of the south tower were loose. The remaining gypsum plaster was raked out from both the upper and lower joints using hacksaw blades. Spacers were used to ensure that upper and lower joints were even and gypsum plaster was injected into the joints and allowed to cure. The new plaster joints were retouched to match existing plaster joints using acrylic paint (Image 16).

A fragment of alabaster stored with the detached finials was found to be a missing fragment from the north side of the shelf. Both break surfaces were thoroughly cleaned with acetone and the fragment was readhered using polyester resin (Steinkitt). However, there were significant losses of surrounding material which was replaced using glass microballoons mixed with 20% Paraloid B72 in acetone and dry pigments to achieve a good colour match. Once the resin had cured, the fill was sanded down and the surface smoothed with acetone (Image 16).

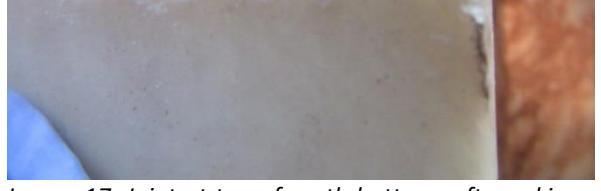
Image 17: Joint at top of north buttress after raking out plaster.

The top two sections on the north buttress were loose. The remaining gypsum plaster in the lower joint was raked out and two slips of lead were used as spacers (Image 17). Gypsum plaster was injected into the joint and allowed to cure (Image 18). The new plaster joint was retouched to match existing plaster joints using acrylic paint.

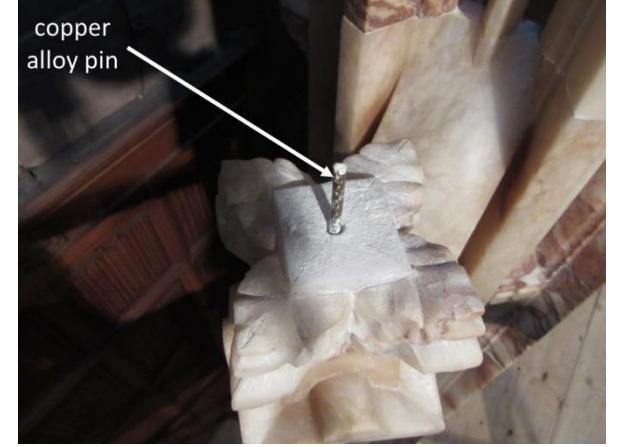
Copper alloy pin holding north 19: Image pomegranate finial from previous repair.

The joint between the pomegranate finial and the north buttress was broken and the finial was held in place by a copper alloy dowel (Image 19). The dowel was removed and replaced with a threaded stainless steel pin (Image 20) which was set in polyester resin (Steinkitt); the joint was filled with gypsum plaster (Image 21). The pomegranate finial on the south buttress was loose, but the finial could not be removed. The remaining plaster was raked out using hack saw blades and the finial was set on new gypsum plaster which was injected into the joint. The new plaster joints were retouched to match existing plaster joints using acrylic paint.

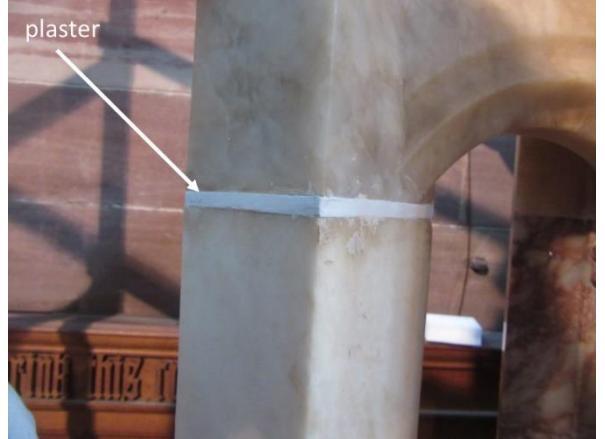
Image 18: Joint at top of north buttress after repointing.

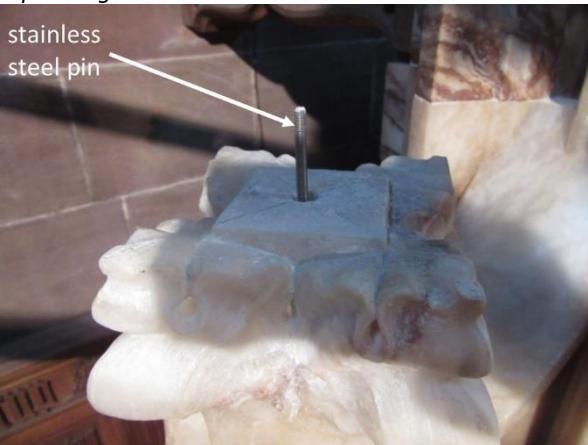
Image 20: Replacement stainless steel pin for north pomegranate finial.

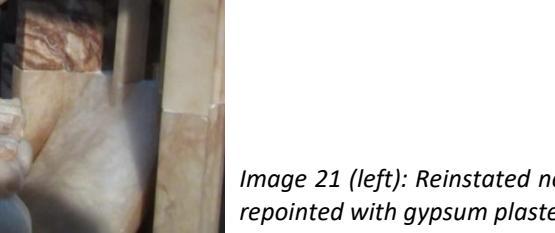
Image 21 (left): Reinstated north pomegranate finial repointed with gypsum plaster.

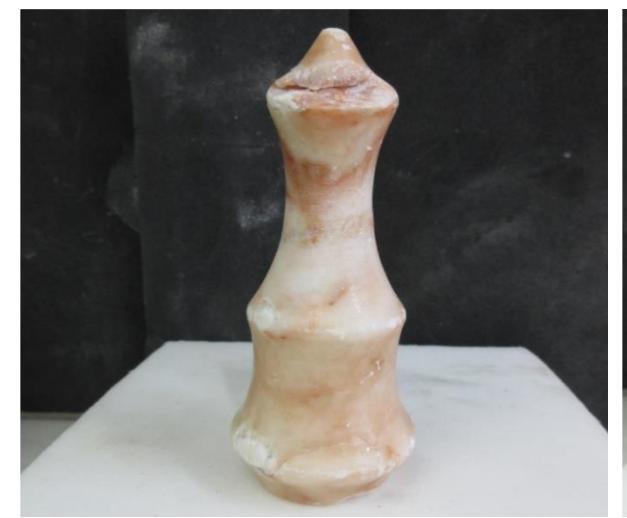
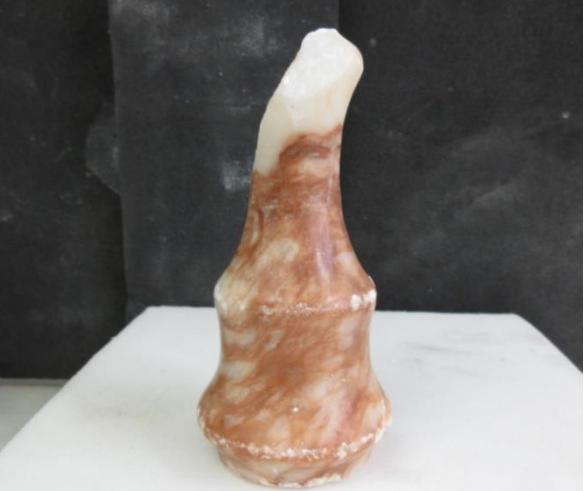
Image 22: Damaged finial (see Image2) after repairs and cleaning.

Image 23: Damaged finial (see Image2) after repairs and cleaning.

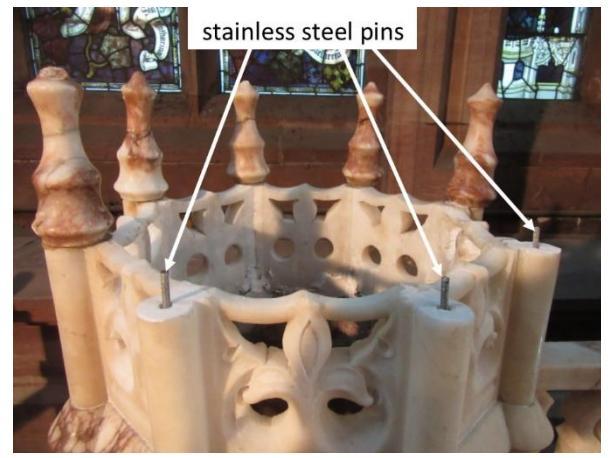
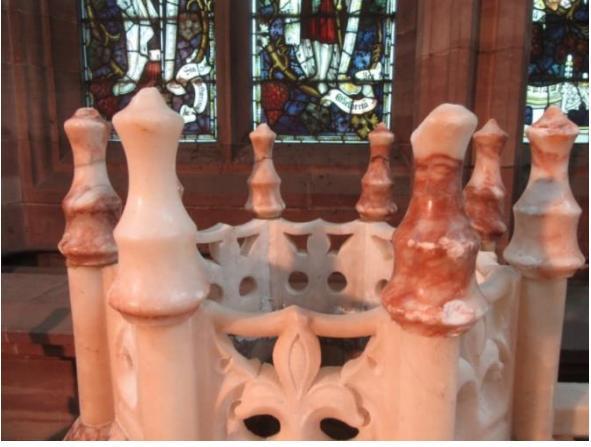
place for finials to be reinstated.

Image 24: North tower with stainless steel pins in Image 25: North tower with detached finials reinstated.

There were six missing finials in total; three from each tower. However, only four detached finials were found. As the finials on the back of the octagons are not visible from the ground, it was decided not to replace two of the finials at the back of the south tower. Three finials were reinstated on the north tower and one on the south tower. Holes were drilled in the bottoms of the finials and in position at the tops of the towers to house 30mm lengths of 2mm stainless steel threaded dowel (Images 24 and 26). The dowels were set in polyester resin (Steinkitt) and the joints were filled with gypsum plaster (Images 25 and 27).

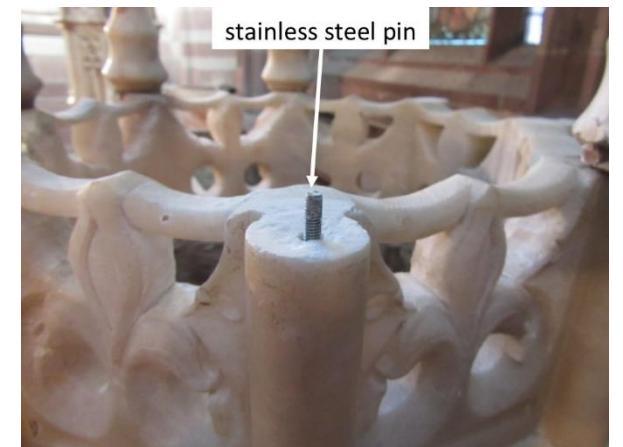
Image 26: South tower with stainless steel pin in place for finial to be reinstated.

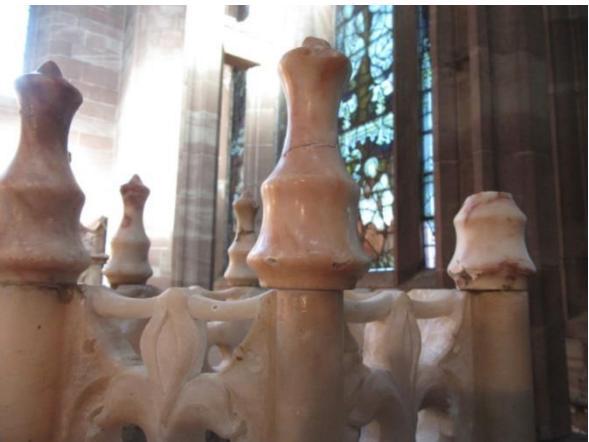
Image 27: South tower with detached finial reinstated.

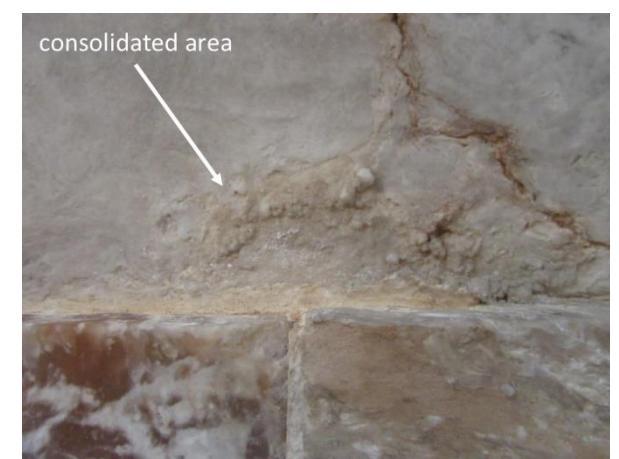
One of the central panels was friable in an area next to the lower edge; this appeared to be caused by water damage, leaving the surface blistered and uneven (Image 28).

*Image 28: Lower edge of panel to north of centre with area of friable stone after consolidation.*

These areas were consolidated by injecting 5% Paraloid B72 in 1:1 acetone and IMS into the stone; excess was removed from the surface using acetone on a cotton wool swab. Fissures and losses of material were filled using glass microballoons mixed with 20% Paraloid B72 in acetone and dry pigments to achieve a good colour match. Once the resin had cured, the fill was sanded down and the surface smoothed with acetone (Image 30).

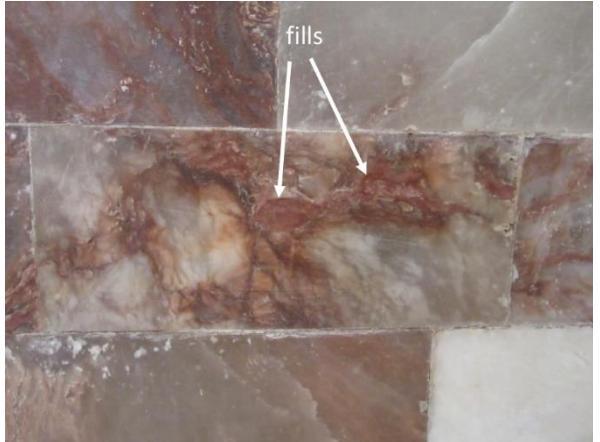
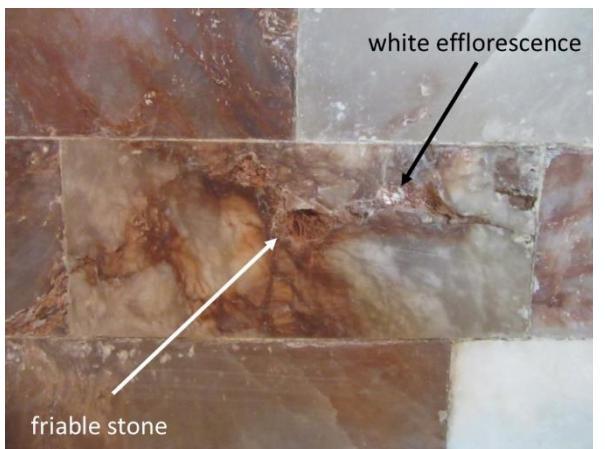
Where the alabaster was heavily veined, the red material was friable and significant amounts had been lost, especially on the ashlar, probably partly as a result of wear and tear in this accessible area (Image 29). A white powdery efflorescence on the surface also indicated that the movement of soluble salts may have contributed to the deterioration (Image 29). Small red fills to similar areas on other parts of the reredos indicated that this was a longstanding problem, probably resulting from natural weaknesses in the stone itself (Image 31).

Image 29: Example of friable stone and white efflorescence on ashlar before treatment.

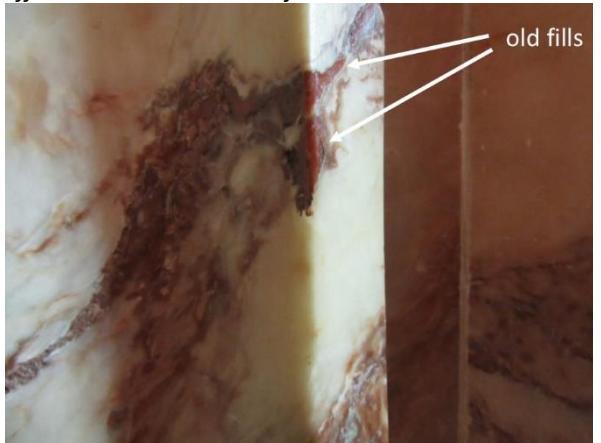
Image 30: Area of friable stone on ashlar after Image 31: Old fills to red veining in alabaster. consolidation and fills.

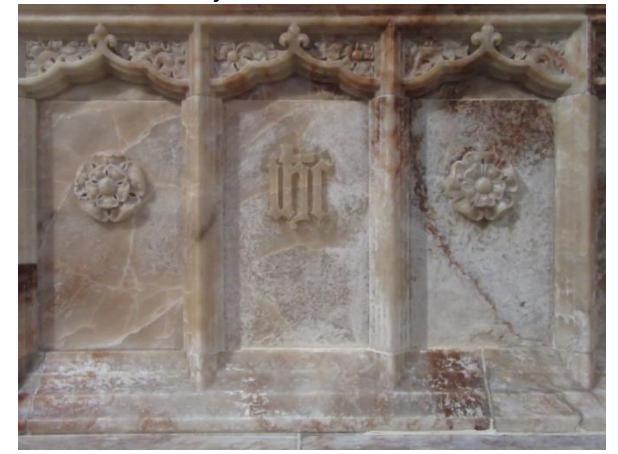
Image 32: Three panels damaged by water after toning down with pigmented microcrystalline wax.

There are signs of water damage on the central panels, the upper surface of the shelf and on the north side of the ashlar. Alabaster is soluble in water and this damage may relate to the custom of placing flowers on the shelf. In order to avoid future damage, extra care should be taken to prevent spillages either by using artificial flower displays or standing flower arrangements in waterproof containers. If any water is accidently spilt on the reredos, it should be removed immediately and not allowed to stand on surfaces or become absorbed into joints.

Light scratching on the surface of the alabaster, particularly on the ashlar was retouched using acrylic paints. Finally, a thin coating of microcrystalline wax was applied to all surfaces on the front of the reredos and lightly buffed using microfibre cloths to remove excess. The wax was mixed with a small amount of raw umber pigment and applied to the two panels to the north of centre that had been lightened due to water damage to tone them down (Image 32).
