# Taylor Pearce Limited, Fishers Court, Besson Street, London SE14 5AS

All Saints' Church Hertford Alabaster Reredos Completion Report February 2019

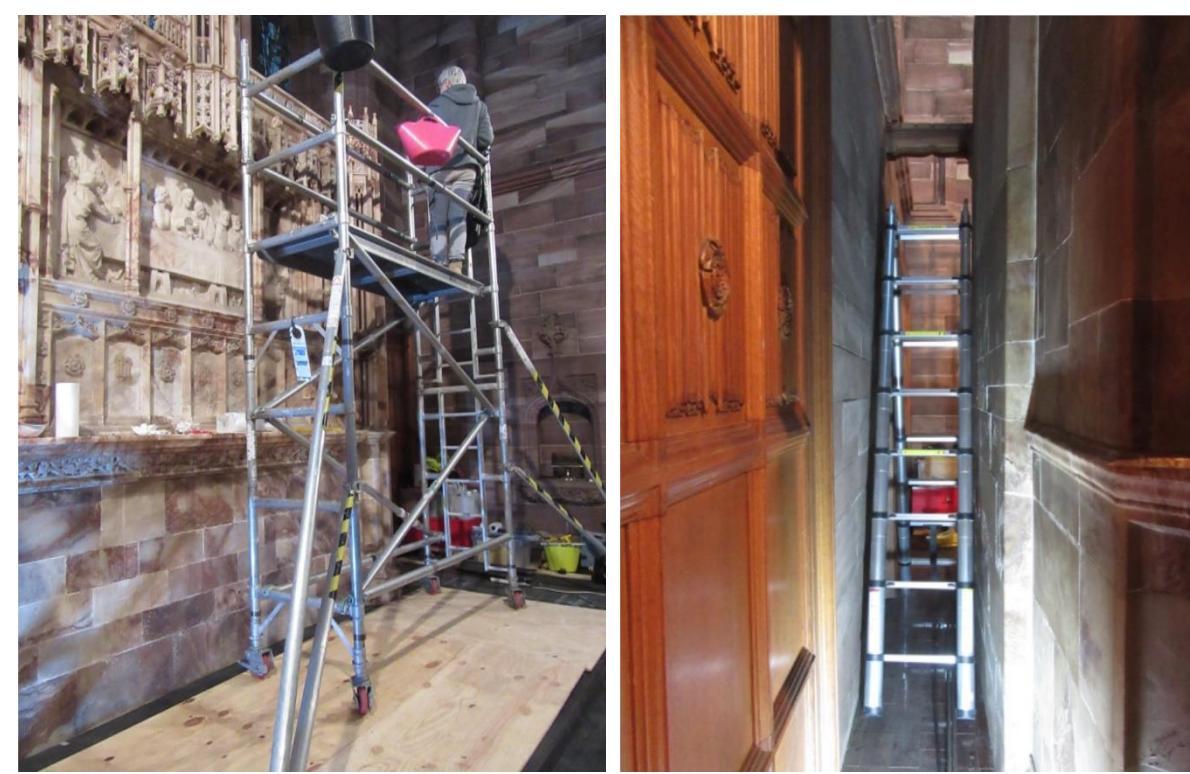
tower used for accessing higher areas.

Image 33: Floor protection and mobile aluminium Image 34: Telescopic ladder used for accessing higher areas in narrow space behind reredos.

The altar was moved off the chancel steps to a position inside the communion rail. The chancel steps were covered with corex sheeting and the area immediately in front of the reredos was protected using ply board. Upper areas of the front of the reredos were accessed from a mobile aluminium tower (Image 33). On the reverse side, the top of the reredos was accessed from a narrow telescopic step ladder (Image 34). Materials and equipment were stored in the chancel during the project; solvents
